Main Conduit Box (MCB) Unit Upgrade

For synchronous and large induction motors

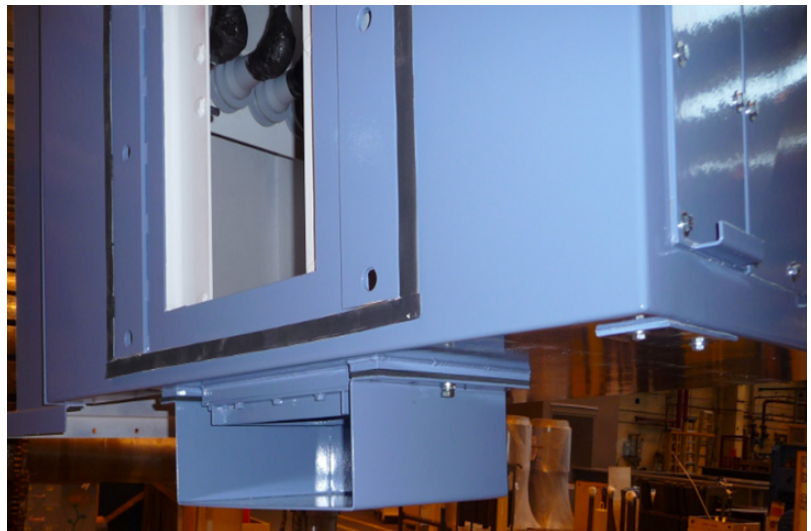
Exclusion vent shown installed on main terminal box.

GE's new modern MCB unit includes a new explosion vent - rupture disk - to safely manage arc flashes or faults in a safe and controlled way.

In the new MCB unit, when arc flash occurs the rupture disc will open, relieving the heat and pressure inside the MCB reducing associated damage to the equipment and risk of injuries to personnel are minimized.
